melett

LOOSE SHAFT NUT

What is loose shaft nut failure?

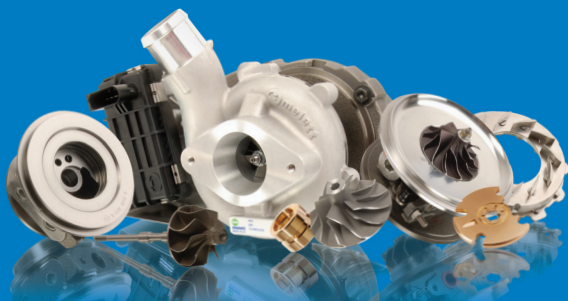
Chipping to the compressor blades
